INDUSTRIAL TANK SOLUTIONS

CASE STUDY

Traditional tank cleaning was impossible for a 140' crude oil tank with an external floating roof because of a 9-foot sludge heel. Automated tank cleaning saved the clients millions.

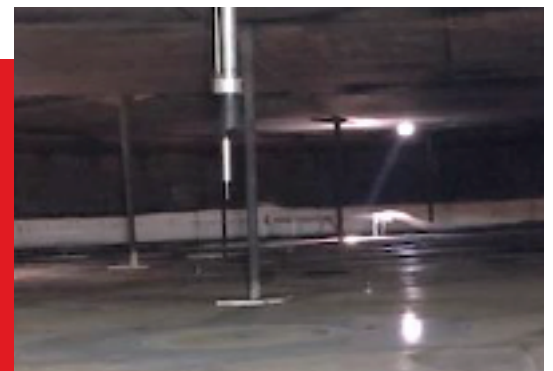
■ Inside the tank before manned entry
